Analysis of Brownfield Cleanup Alternatives (ABCA)

Baltimore Street Property
1307 West Baltimore Street
Defiance, Ohio

October 22, 2024

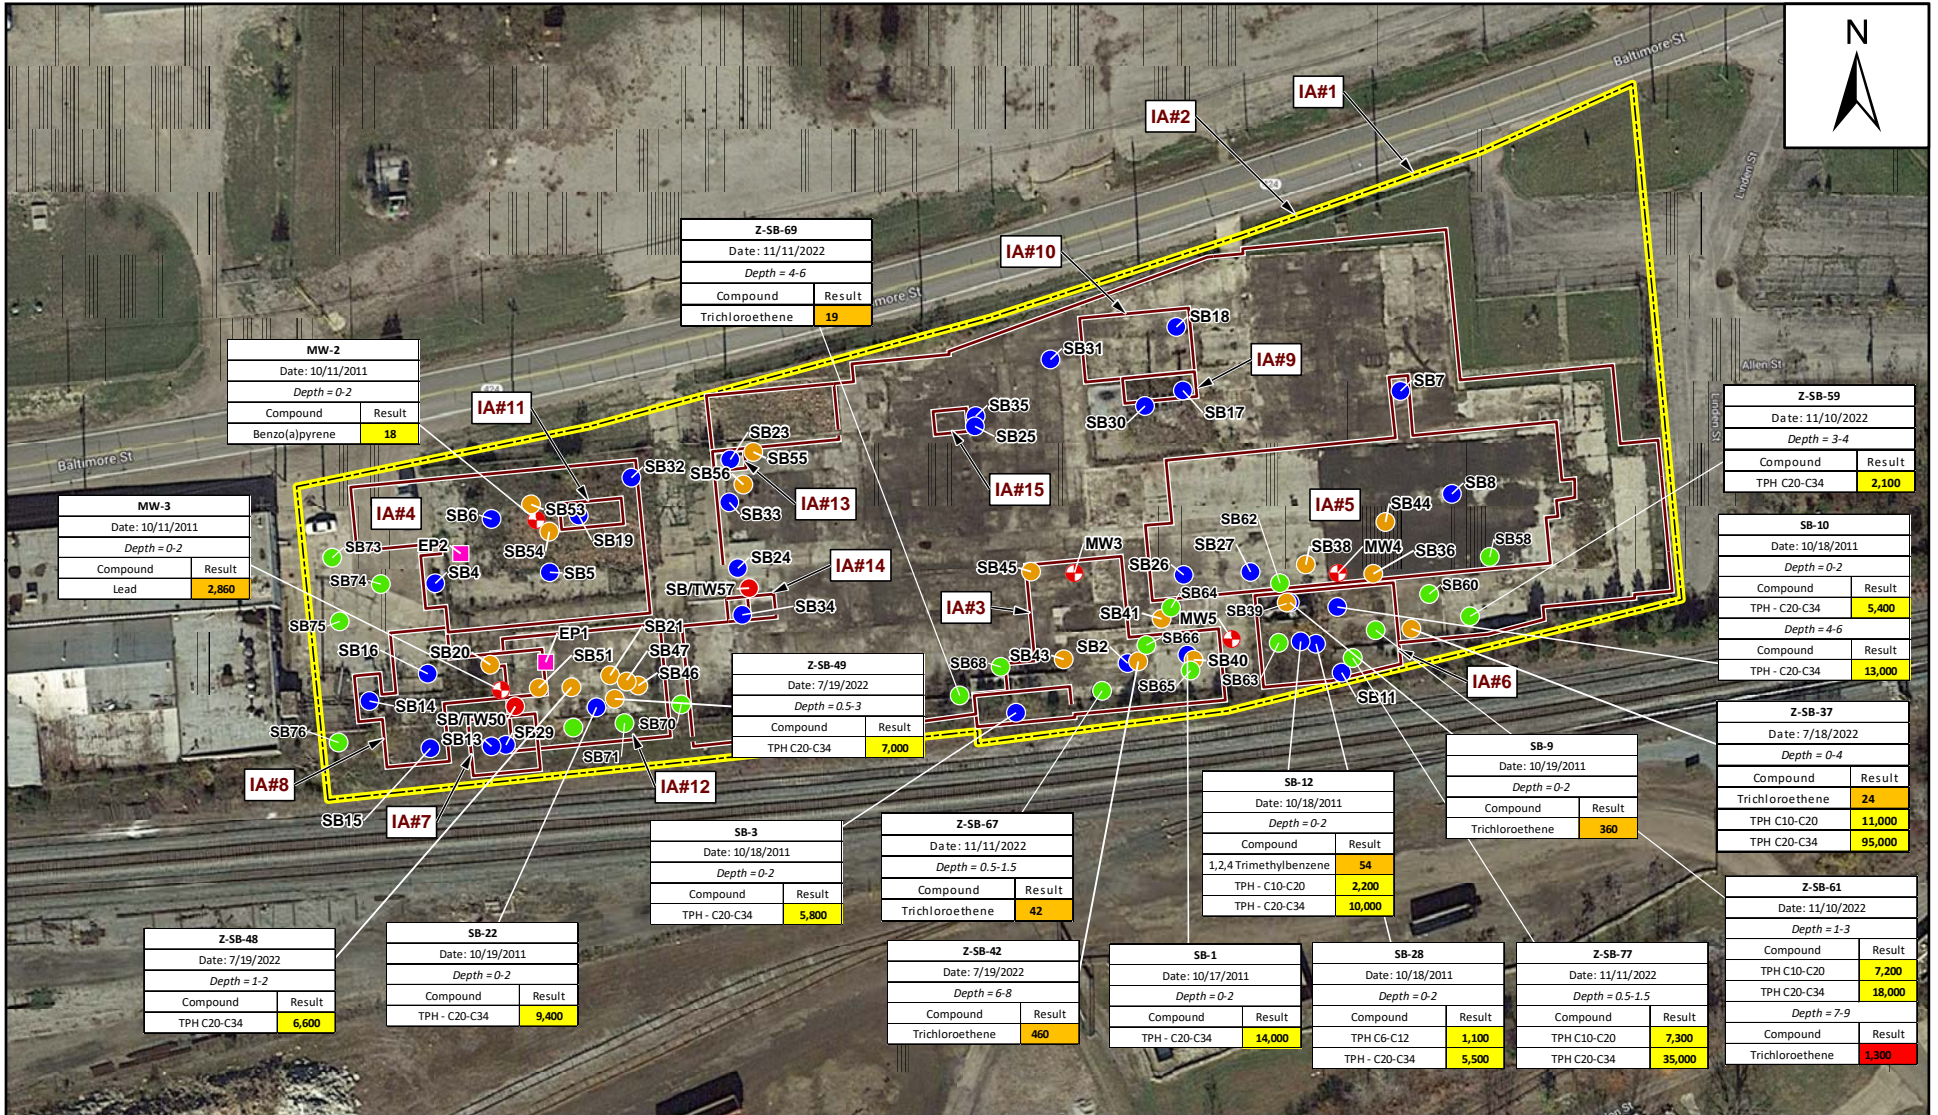
Figure 3
 Delineation Boring Locations

xxxx	Result exceeds BUSTR soil saturation limits
xxxx	Result exceeds VAP construction/excavation direct contact standards
xxxx	Result exceeds VAP commercial/industrial direct contact standards

Tetra Tech conducted a Second Supplemental Phase II PA on November 10 and 11, 2022 that included the installation of 20 soil borings to a depth of 10 feet bgs using DPT (SB58 through SB77) and collecting soil samples from each soil boring for VOC and/or TPH analysis; additionally, Tetra Tech collected samples for PCB, and metals analysis near locations of prior exceedances. Samples were also collected for toxicity characteristic leaching procedure (TCLP) VOC analysis to determine whether soil if excavated would exhibit a hazardous characteristic based on leachate concentrations. Samples were submitted to ALS located in Cincinnati, Ohio for analysis. **Figures 2 and 3** show sample locations and exceedances of applicable standards. Results for PCBs and metals did not exceed GDCSS standards, which addressed data gaps relating to the extent of exceedances of those COCs.

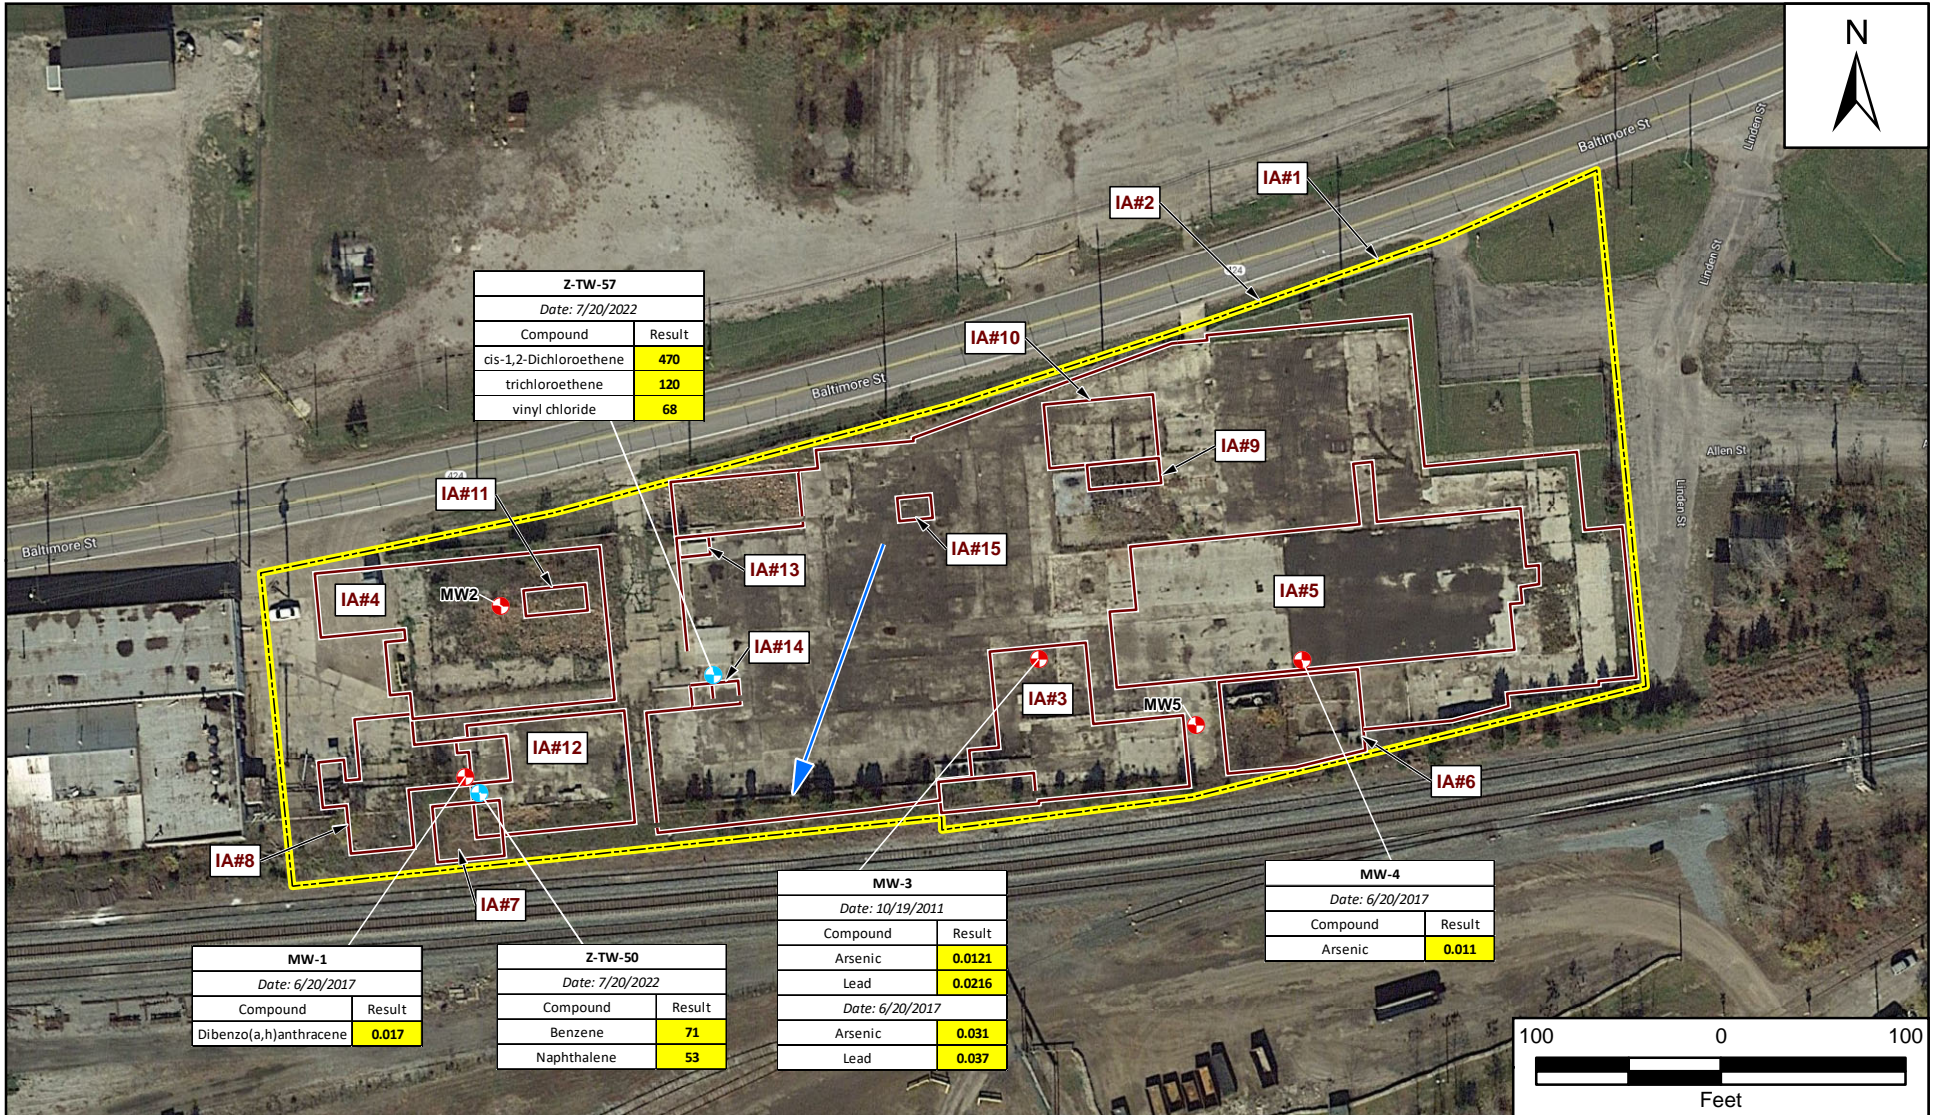
Figure 4
 Groundwater Results Exceeding Ohio
 VAP UPUS for Groundwater

- ⊕ Soil Boring/Temporary Well Location - July 2022
- ⊕ Monitoring Well Location - July 2017
- Approximate Property Boundary
- Identified Areas
- ➔ Groundwater FLOW Direction
- Result exceeds Unrestricted Potable Use Standard

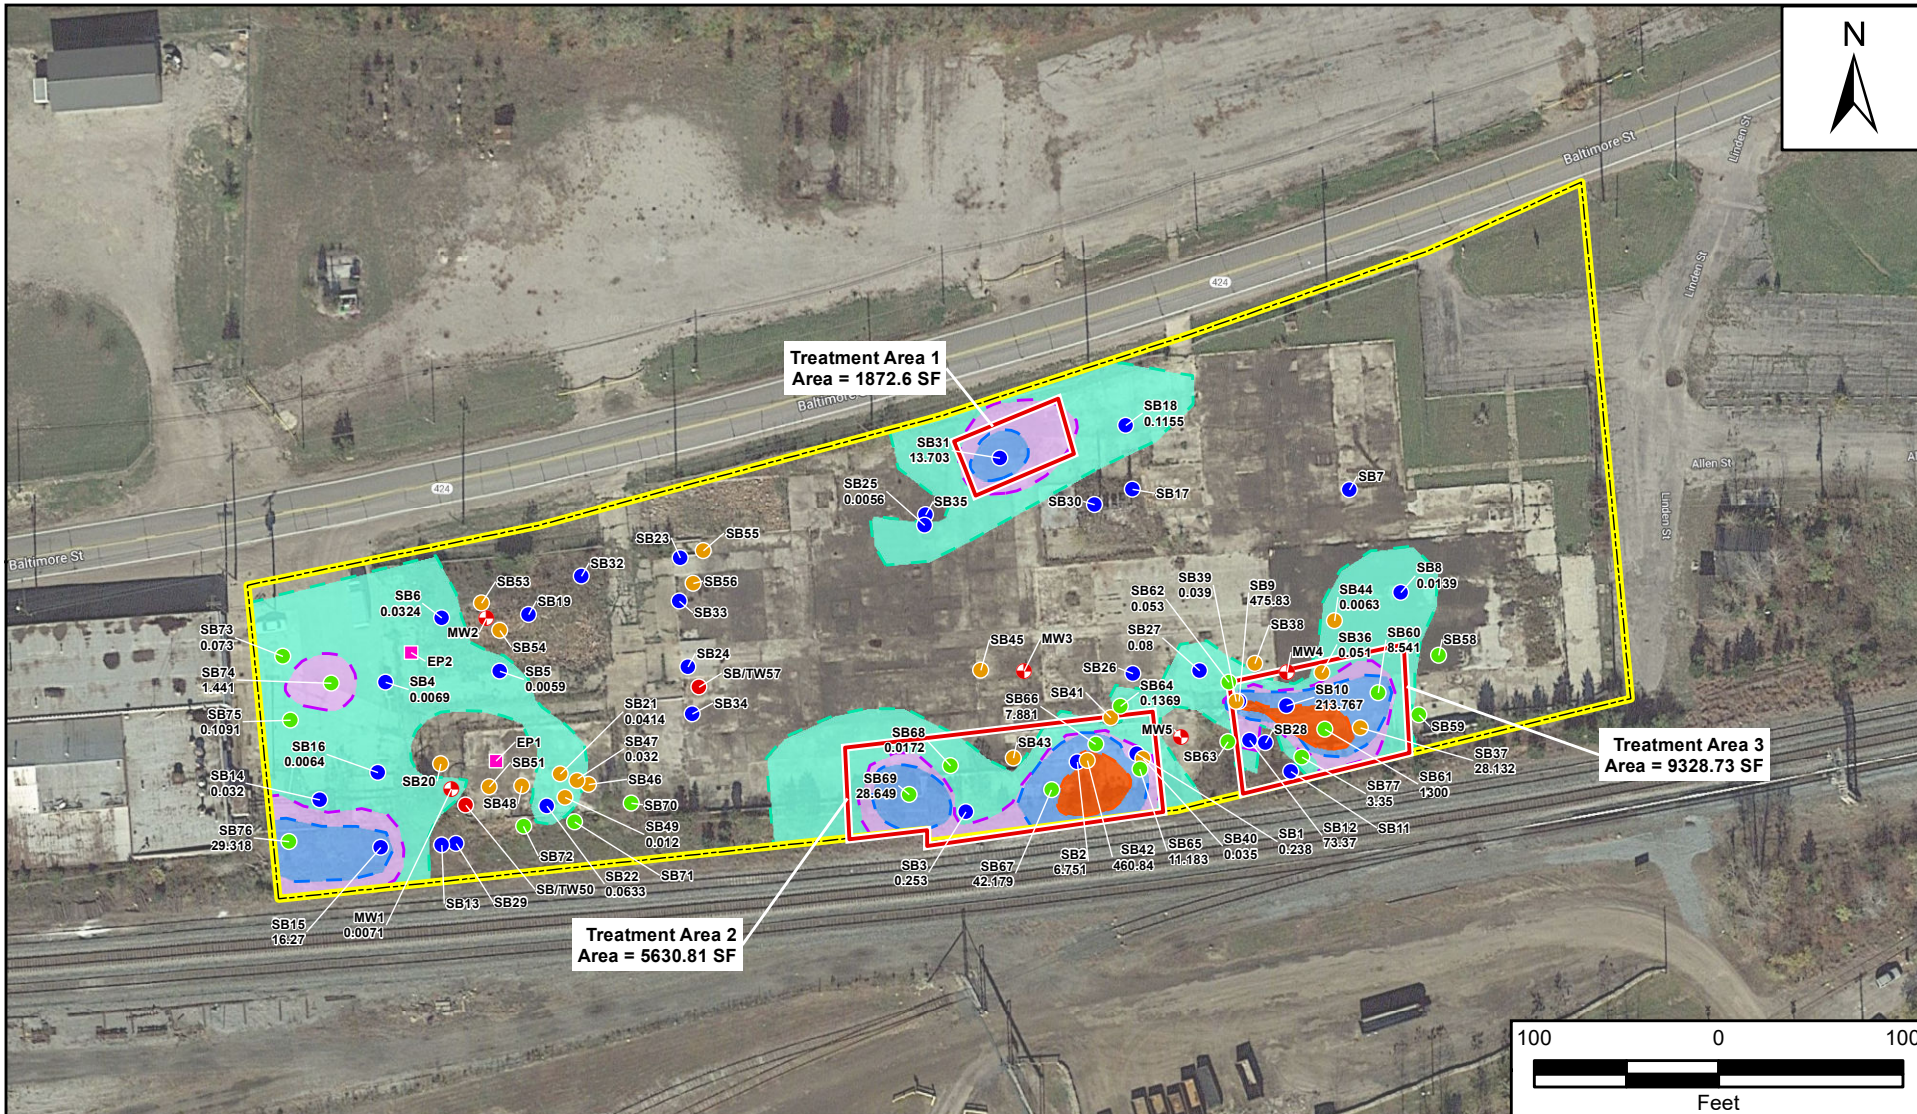
Figure 8
Potentially Hazardous Soil Areas

- VOC Contours**
- 0 - 0.5 mg/kg
 - 0.5 - 5 mg/kg
 - 5 - 50 mg/kg
 - 50 - 500 mg/kg
- Treatment Area**
- Treatment Area
 - Approximate Property Boundary

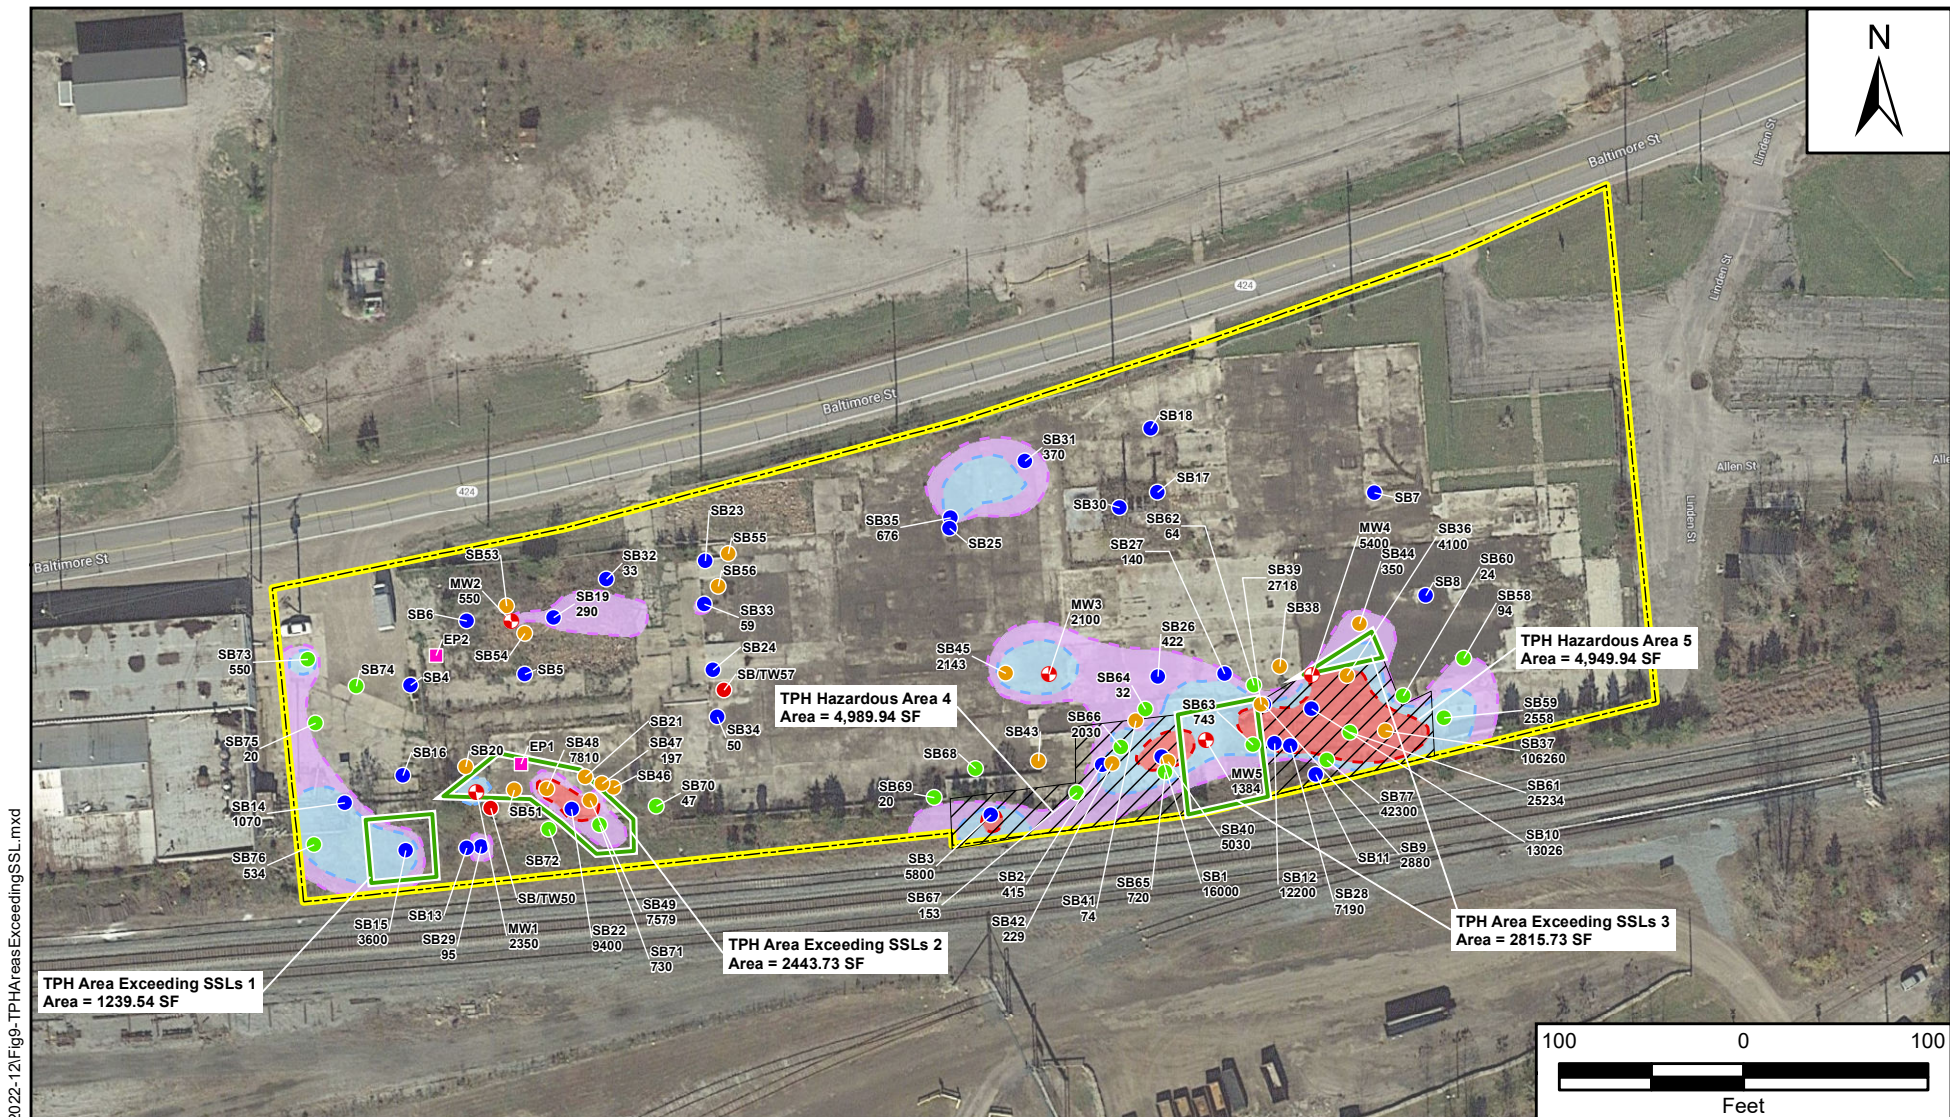
TPH Area Exceeding SSLs 1
Area = 1239.54 SF

TPH Hazardous Area 4
Area = 4,989.94 SF

TPH Hazardous Area 5
Area = 4,949.94 SF

- TPH Contours**
- 50 - 500 mg/kg
 - 501 - 5,000 mg/kg
 - Above 5,000 mg/kg
 - Non-hazardous Waste Excavation Area
 - Non-hazardous TPH and Hazardous VOC soil
 - Approximate Property Boundary

Soil will be treated in-situ using thermal desorption to reduce concentrations of VOCs to below hazardous concentrations, followed by removal and off-property disposal of treated soil as non-hazardous waste. As with the prior two options, the excavation would be backfilled. The areas where treatment is considered necessary are identified on **Figure 8**. Soil that exceeds TPH SSLs, but is not considered potentially hazardous, is identified in **Figure 9**.
